# Case Study: Centrifuge Control

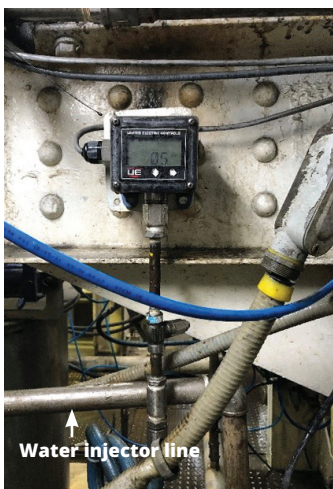
Excelsa installed on a water injector line of a centrifuge

The mechanical switches on the centrifuges were replaced with UE's Excelsa electronic switches. Each Excelsa switch was installed along the centrifuge's water injector line to ensure that the water was injected into the drum at 90 psi. When the pressure falls below the 90 psi setpoint, the Excelsa shuts down the centrifuge system via the programmable logic controller (PLC). The centrifuge is reactivated once the water pressure is restored.

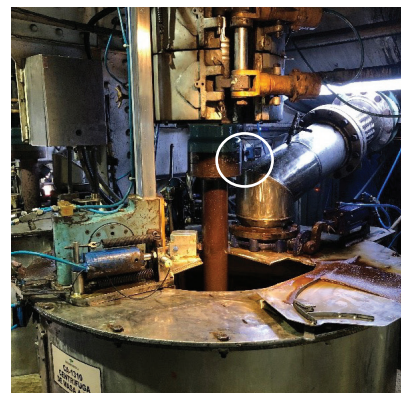
Individual centrifuge with the Excelsa (circled)
